Manhole Inspection Summary

Manhole # S49M__012MH

Insp Date: **9/16/09 9:29 AM**

Location Address: **2414 Hudson St.**

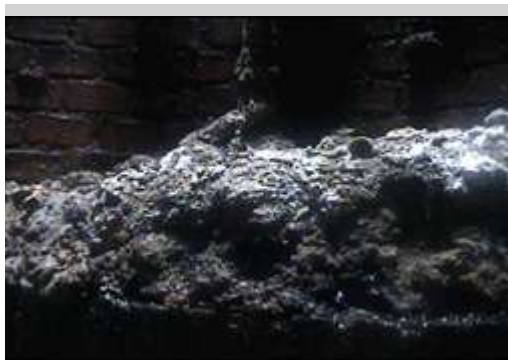
Defect 1

Condition: ☐ Sound ☐ Cracked ☐ Root Intrusion ☐ Deteriorated ☐ Leaks ☒ **Debris**

debris on the bench

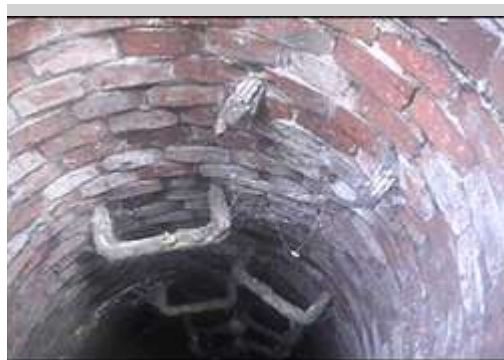
Defect 3

Steps Count: **9** Missing: **1** ☒ **Corroded**

missing and corroded rungs

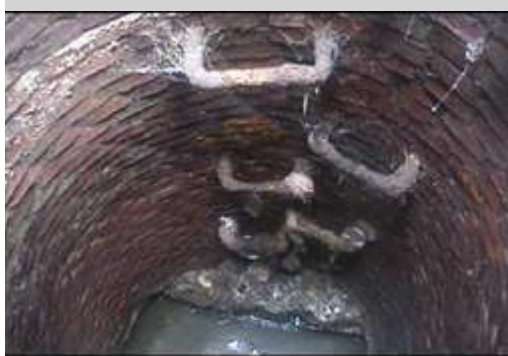
Defect 2

Surcharge ☒ **Evidence Of Surcharge** Depth: **5** (ft.) ☐ Active Surcharge Present

surcharge evidence

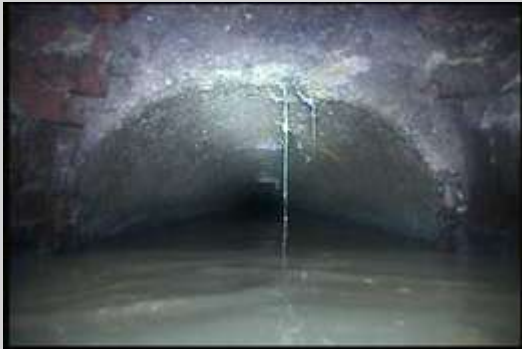
12 O'Clock Outflow

Pipe Height: **27.6** (in.) Rod and Bar (Angled)
Pipe Material: **Clay** ☐ Pipe Lined
Invert Depth: **15.30** (ft.) Flow Characteristics: **None**
Deposits: ☒ None ☐ Mud ☐ Sludge ☐ Debris ☐ Grease
Silt Depth: **0** (in.) Deposits Extent:
Infiltration: **None** Pipe Seal Cond: **Sound**

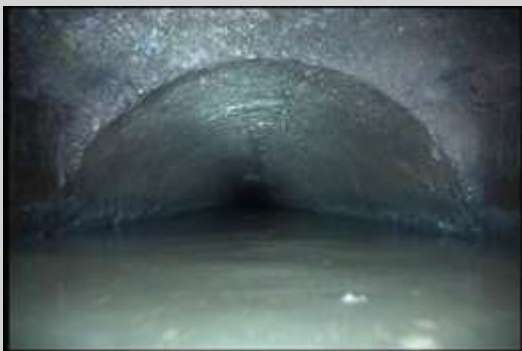
6 O'Clock Inflow

Pipe Height: **27.6** (in.) Rod and Bar (Angled)
Pipe Material: **Clay** ☐ Pipe Lined
Invert Depth: **15.20** (ft.) Flow Characteristics: **None**
Deposits: ☒ None ☐ Mud ☐ Sludge ☐ Debris ☐ Grease
Silt Depth: **0** (in.) Deposits Extent:
Infiltration: **None** Pipe Seal Cond: **Sound**
